Historic Building Features at 1 High Street

By Roger Lea

The Sutton Coldfield Local History Research Group undertook a project to make a historic building record of 1 High Street. The full report of this is deposited in Sutton Coldfield Library. As part of this project, over 200 photographs were taken, some of which may prove useful for comparison when other buildings come to be studied.

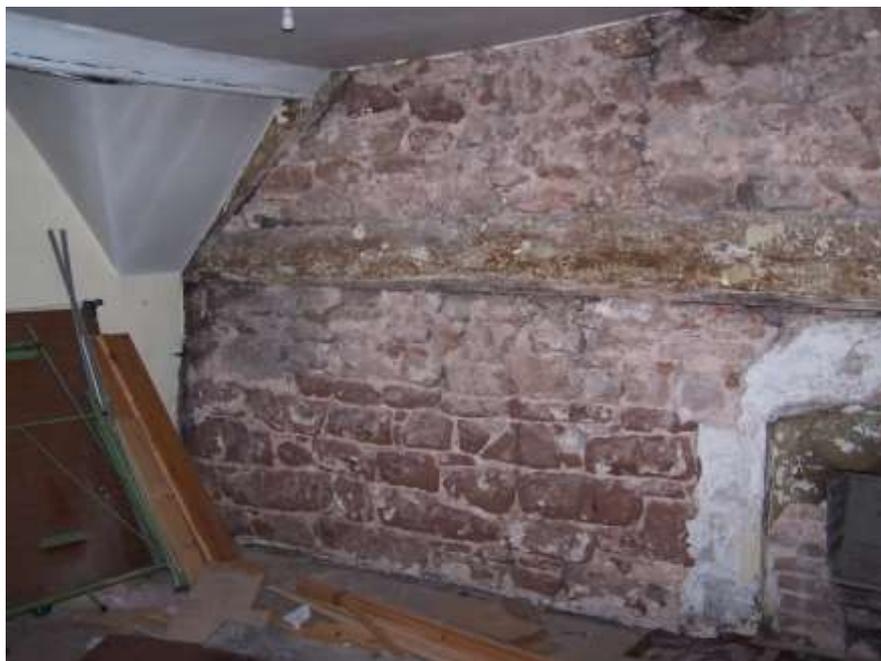
The building was constructed of stone in 1623, after a previous timber-framed inn had burned down. In places, the original stone walls were exposed, showing that local sandstone had been used. On the second floor, the interior stone wall of the north gable encases a massive tie-beam and the principal rafter. On the outside of this wall

is a large protruding stone chimney, but ancillary buildings made it inaccessible for close inspection.

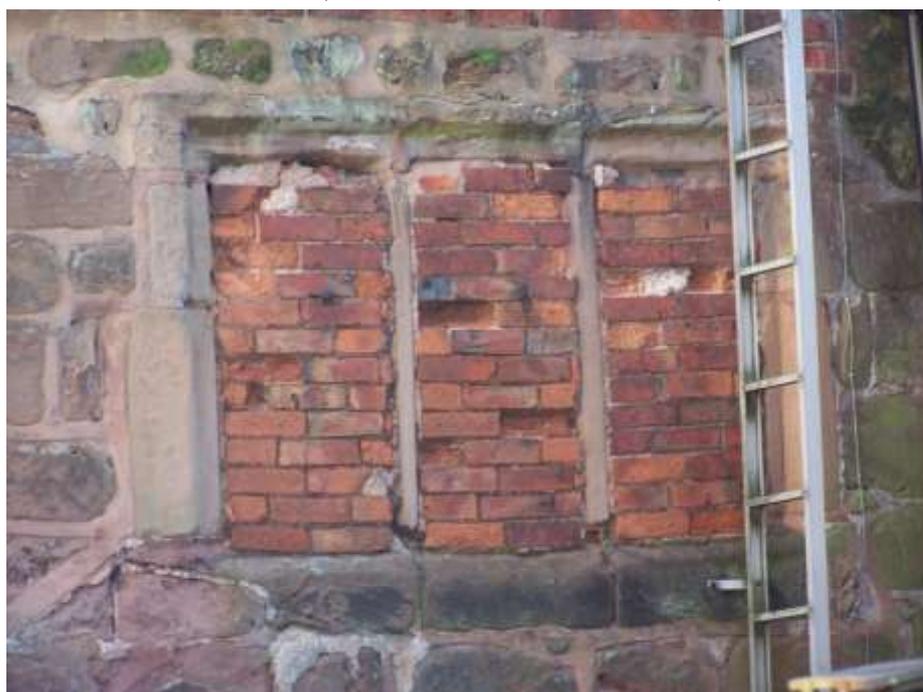
The stonework was also exposed on the east wall, where there was a bricked-in window frame. The stone window frame was moulded, and it had moulded mullions, but the sill was missing. Once again, it was not possible to get very close, but details of the window could be studied on the high quality digital photograph.

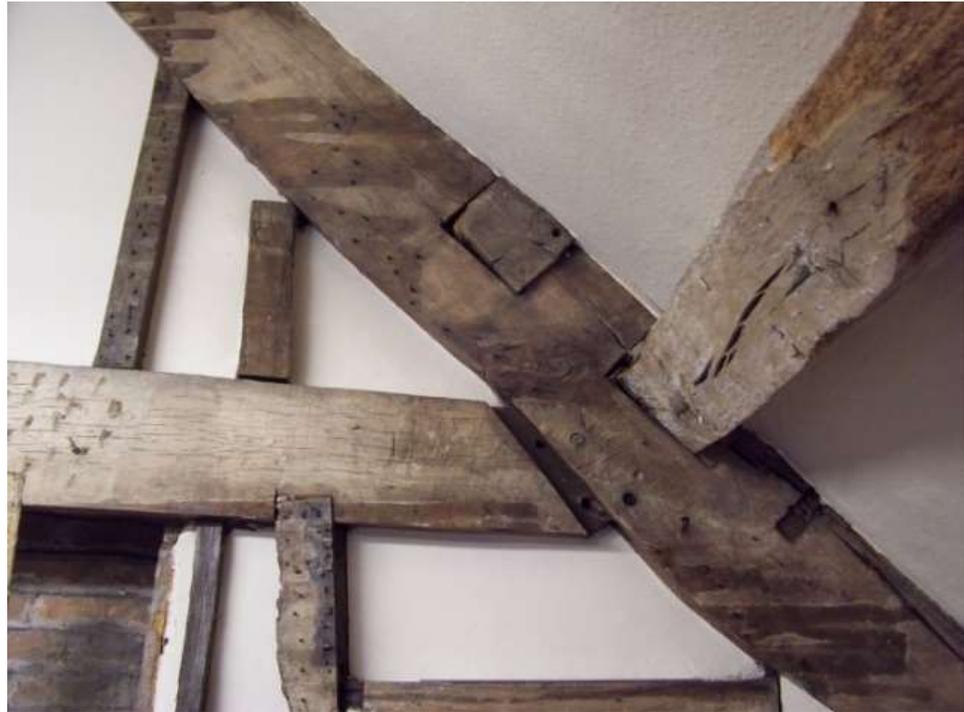
The purlins (beams which support the roof) were trenched into the principal rafters, as shown here. (The tenon of the tie beam has been pulled out of the mortice joint due to the movement of the building, breaking the pegs which had secured it – the building has been stabilized since).

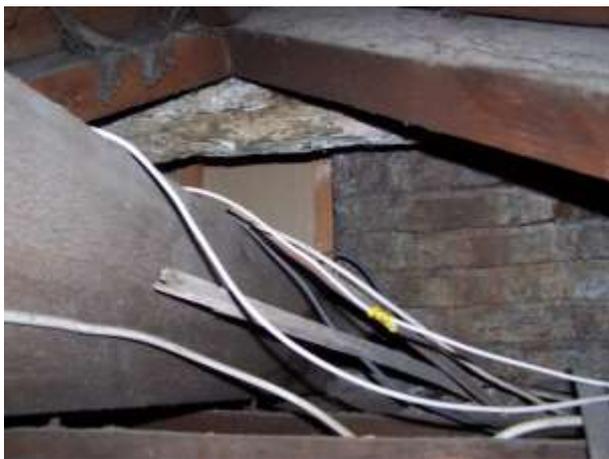
The detail of the

junction of the roof of the wing to the main roof could only be seen by torchlight, standing on

a ladder, so flash photography gave a better view. We were so busy measuring that we failed to notice

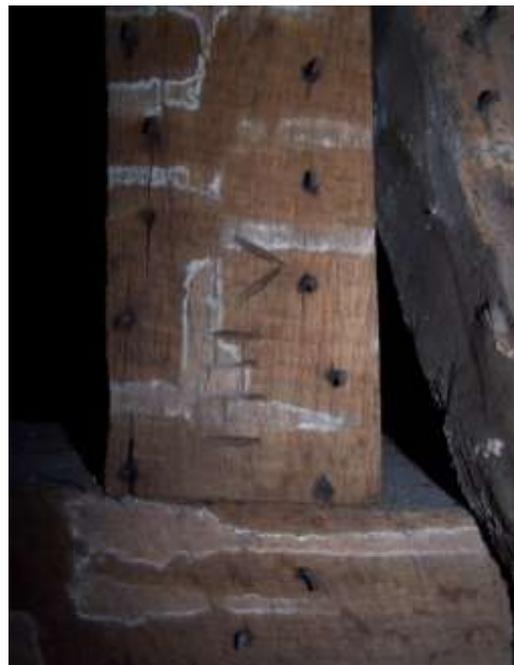
the carpenters marks until our third visit – this reads IIIIV, being the ninth stud in the wall framework. The stud is fastened with a mortice and tenon joint secured by a peg; the studs in the other partition walls were nailed into position.

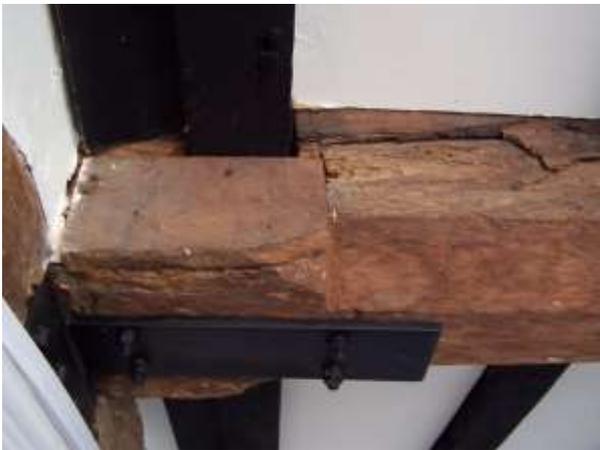
On the first floor the exposed timbers were

chamfered, but in places decay had weakened them,

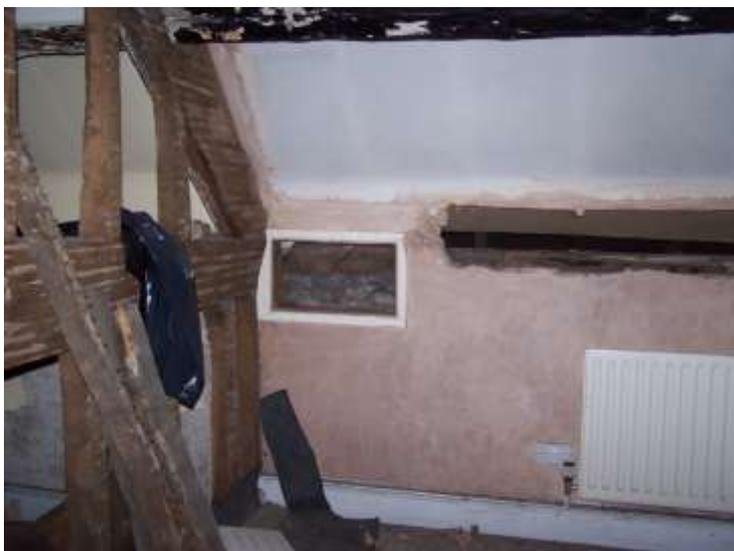
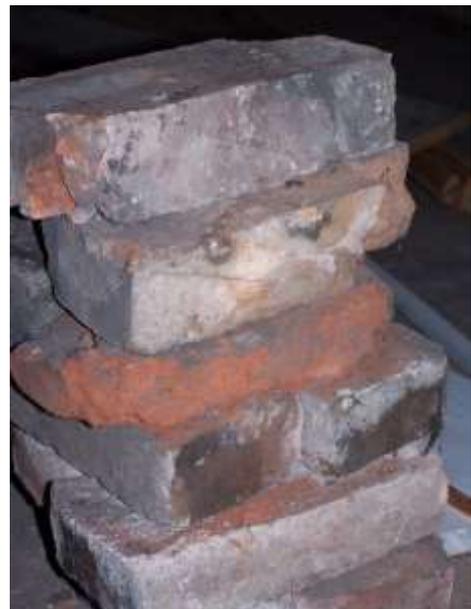
At the top of the street wall there was a gap where details of the eaves could be seen. On the outside was the stone cornice, then the top of the Georgian brick façade, then the stone wall with a decayed wall plate on top of it, and this was lined on the inside by a wall of bricks placed on their sides. Some of the bricks which had been removed were stacked on the floor, these were narrow bricks dating from about 1700 with the characteristic diagonal mould mark.

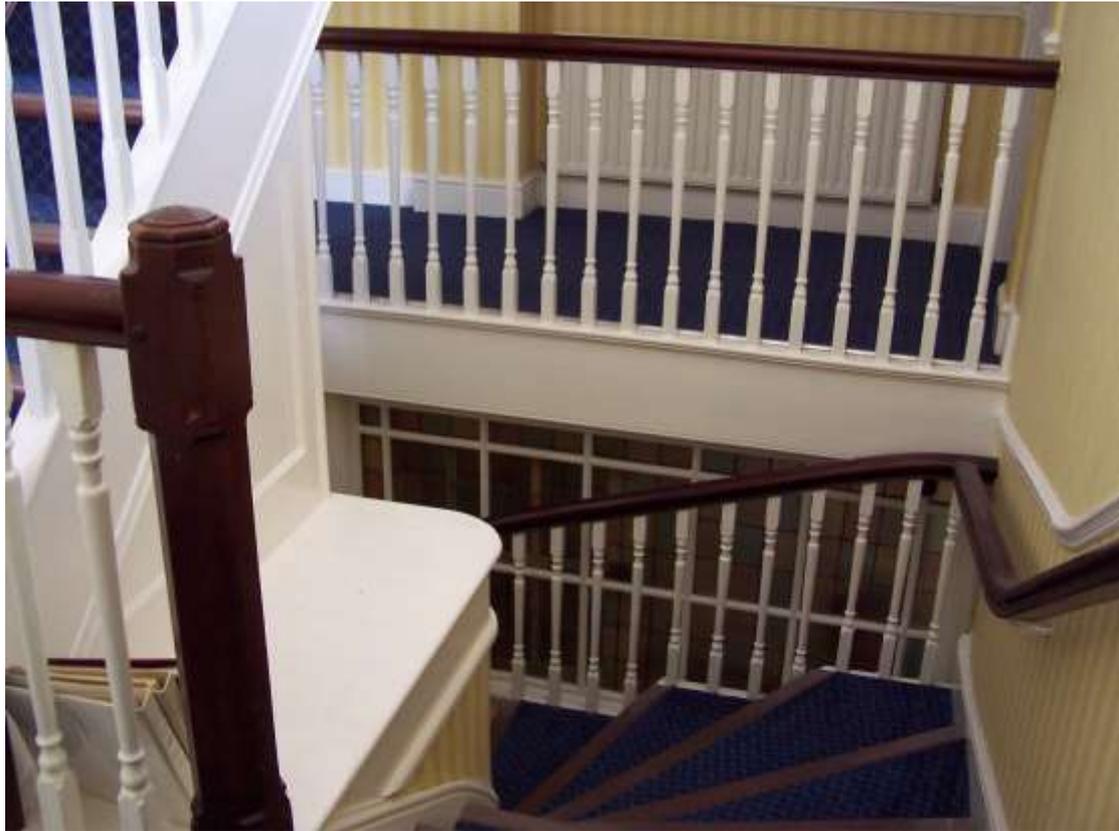
The owner, Kimberley Kong, is proud of the building and is restoring it sympathetically, as can be seen in the handsome staircase.
