Archaeological Buildings Recording and Watching Brief at Peddimore Hall Barns Sutton Coldfield, January-March 2010

Report 10/75

May 2010

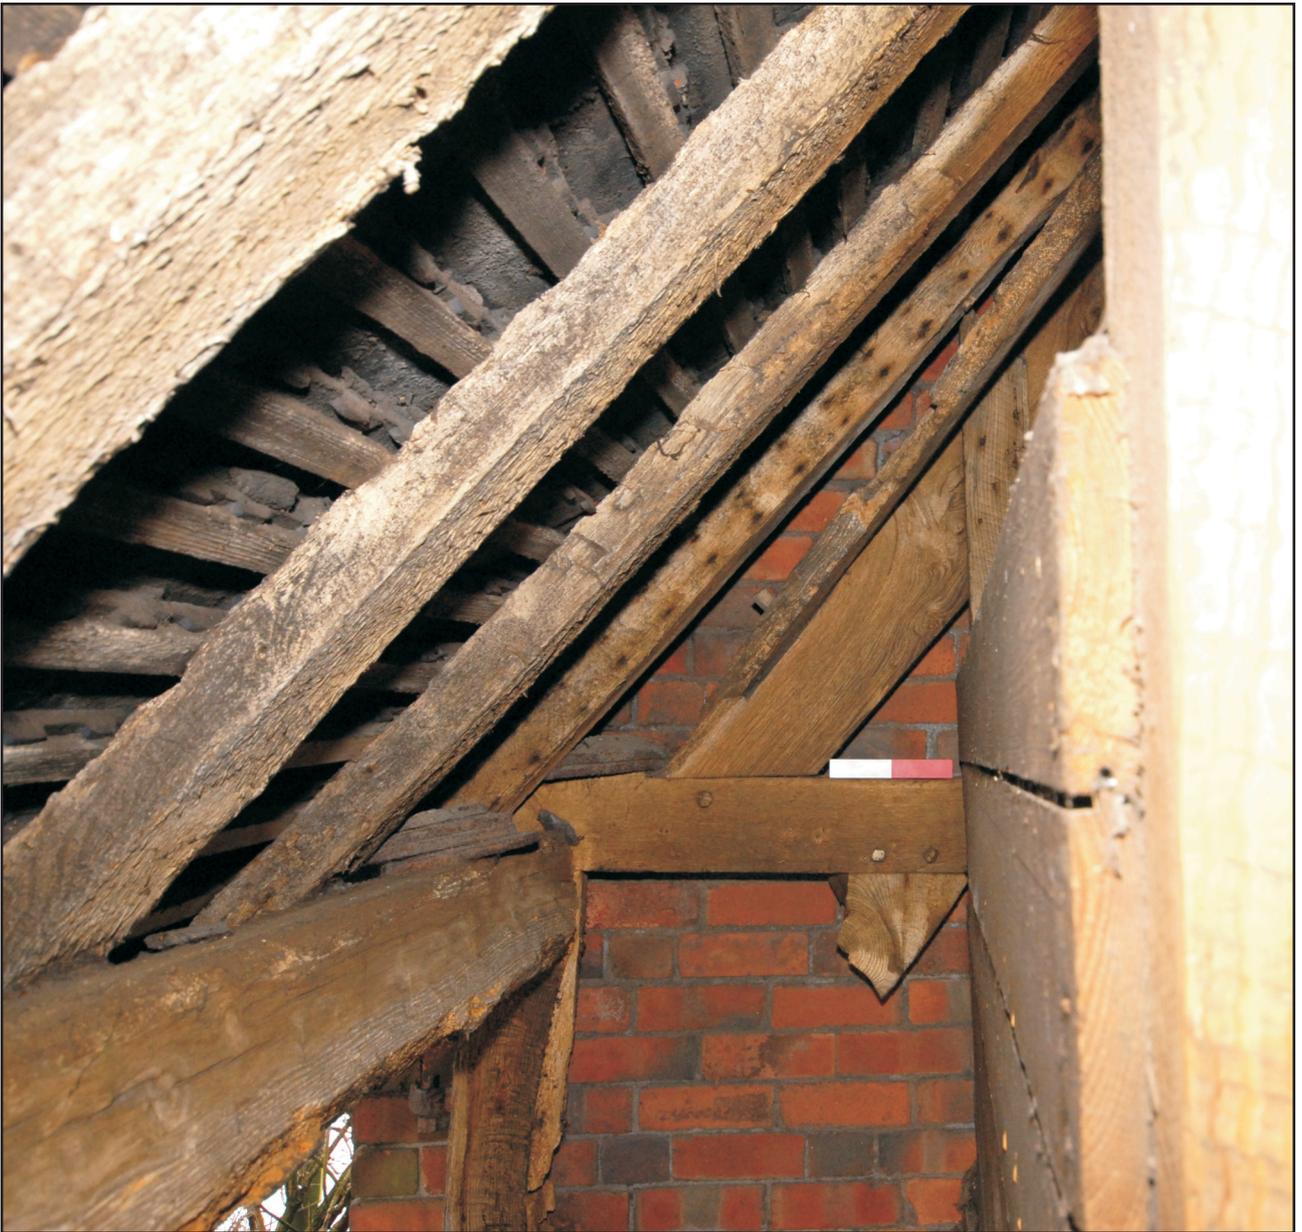
Detail of Truss 1 Fig 4

An additional strut had been inserted on the eastern side to act as a further support for the principal rafter after a hole had been cut into it for a drive shaft between Trusses 1 and 2. On the western side of the tie beam there was the remnant of a brace to the wall post which had been cut off (Fig 4).

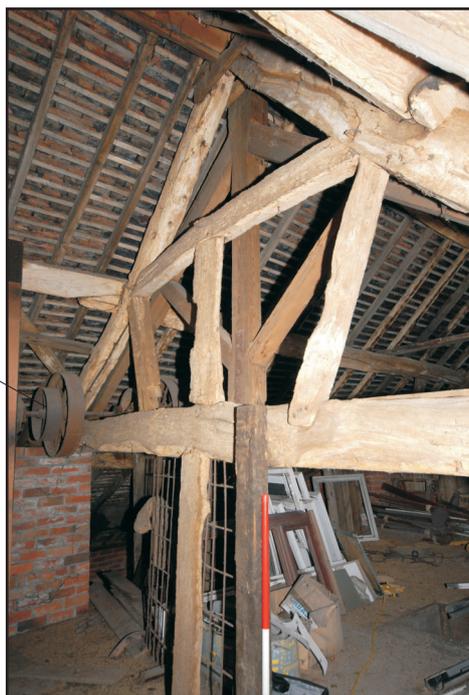
Truss 2, elevation and photograph Fig 5

Truss 2 represents the most complete of all of the trusses within the building, and it is 15th to 16th-century in style. Four dendrochronological samples were taken from this truss (4-6 and 8), two of which could not be dated (See Appendix 1). The remaining two produced the same date of 1509-34 (Fig 5).

The truss is a variation of the Queen Post roof, (the eastern strut was dated to 1509-34, but was itself a replacement timber), with the addition of a central strut from the tie beam to the collar. The truss was connected to the wall post on the western side by a brace (dated to 1509-34 by dendrochronology) (Fig 6). The wall post was in turn linked to the wall plate by a further brace, making this truss integral to the building (Fig 7). Attached to the wall post was a horizontal mid-rail which was joined to the tie beam by a vertical post morticed in at both ends (Fig 5). The western principal rafter was joined to the purlin by a wind brace. The other brace was missing although joint evidence remained.

The principal rafters, collar, tie beam and mid-rail all had stave holes, with the mid-rail having three mortices as well, which may suggest that this truss had formed a partition wall, with wattle infill.

Note drive shaft and bell-wheels

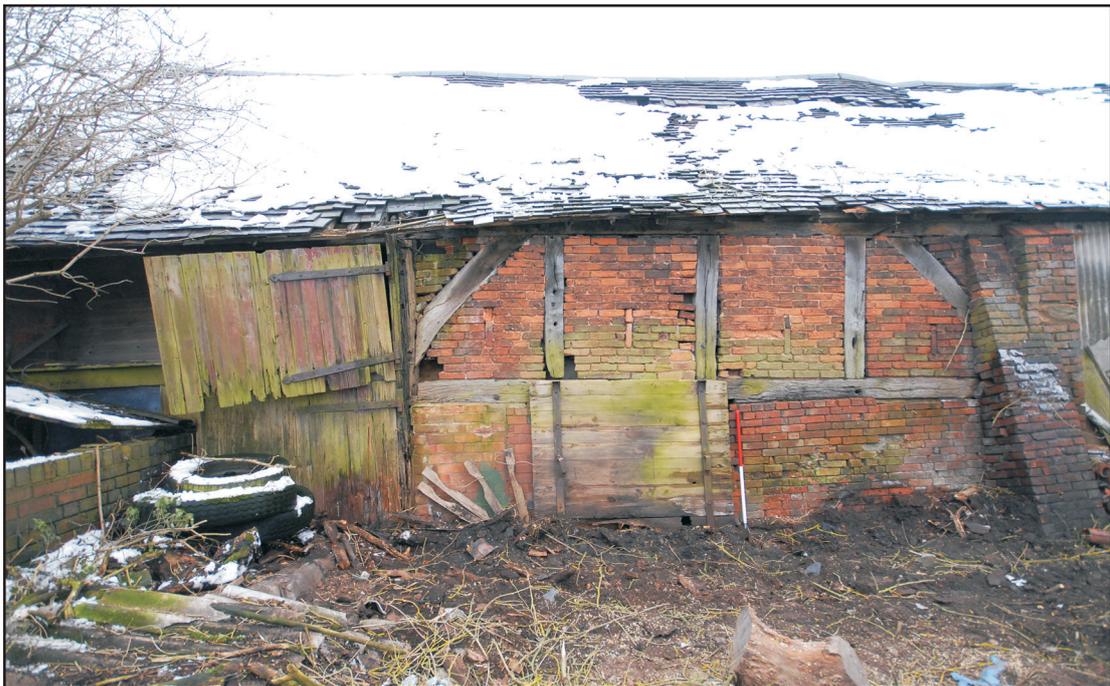
Wall 1, elevation and photograph Fig 7

On the north-western side of the building there was a surviving section of timber framing, which joined elements of Trusses 1 to 3 (Fig 7). The timber in this wall was not suitable for dendrochronological sampling, due to there not being enough surviving rings. The section of framing consisted of the wall posts for Trusses 1 and 2 with the wall plate, purlins and ridge piece joining Trusses 1 to 3. Between Trusses 2 and 3 was a mid-rail with three vertical beams between it and the wall plate, in the panels adjacent to Trusses 2 and 3 were diagonal braces. The panels were in-filled with brick.

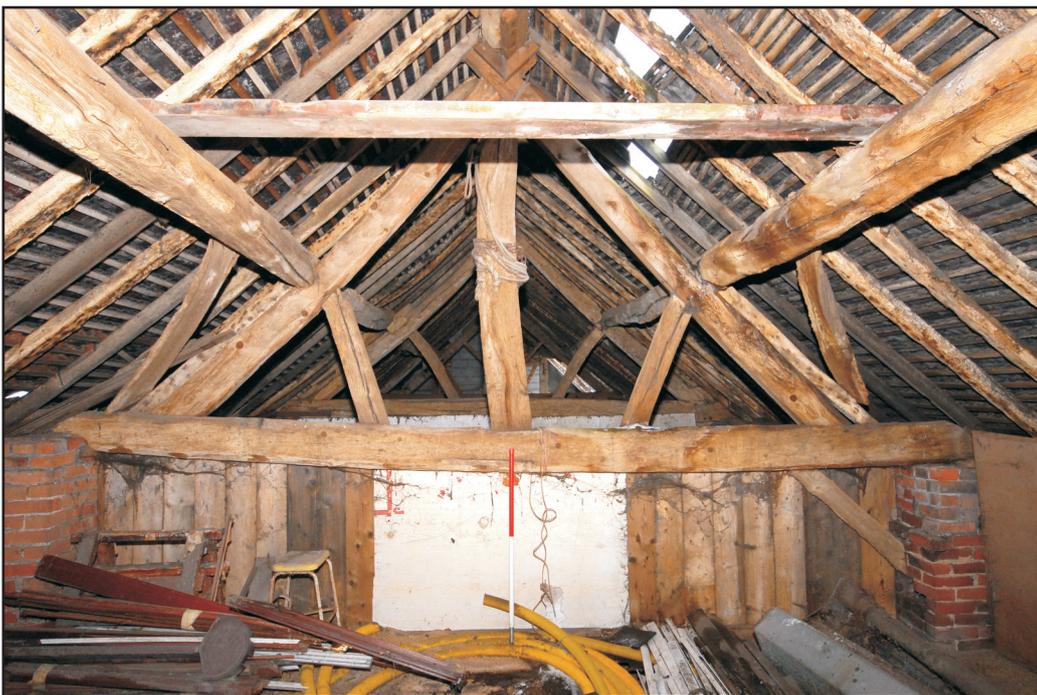
Truss 3, elevation and photograph Fig 8

Truss 3 was a King Post truss, (Fig 8), only one dendrochronological sample was taken from this truss from the King Post (9) which was undated (See Appendix 1). The tie beam and the eastern principal rafter were marked with the same carpenter's

mark, (a vertical line with three diagonal lines scored through it followed by a B), suggesting that they were part of a set (Fig 9). The eastern purlin was trenched into the principal rafter, although a chock had been added as a support (Fig 8). The western purlin was not trenched into the principal rafter and was supported by a wooden chock (Fig 8). This rafter was likely to have been a replacement as it was in pine.

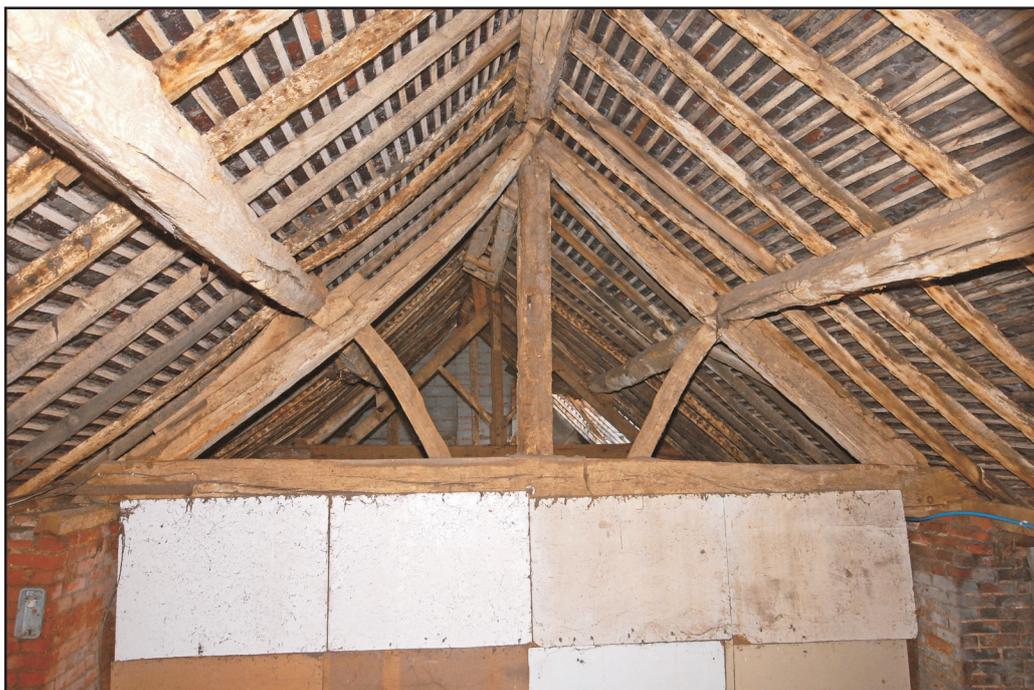
Truss 4, elevation and photograph Fig 10

This truss was a King Post truss. Two dendrochronological samples were taken, one from the eastern purlin (10), producing a date of 1509-34, the other was from the eastern strut which produced a date of 1741-66 (16), (Fig 10). The tie beam on its eastern side had a mortice for a missing brace. The eastern principal rafter had been trenched for the purlin, but the purlin was supported by wooden blocks and a chock (Fig 10). The western principal rafter had a slot for a missing wind brace.

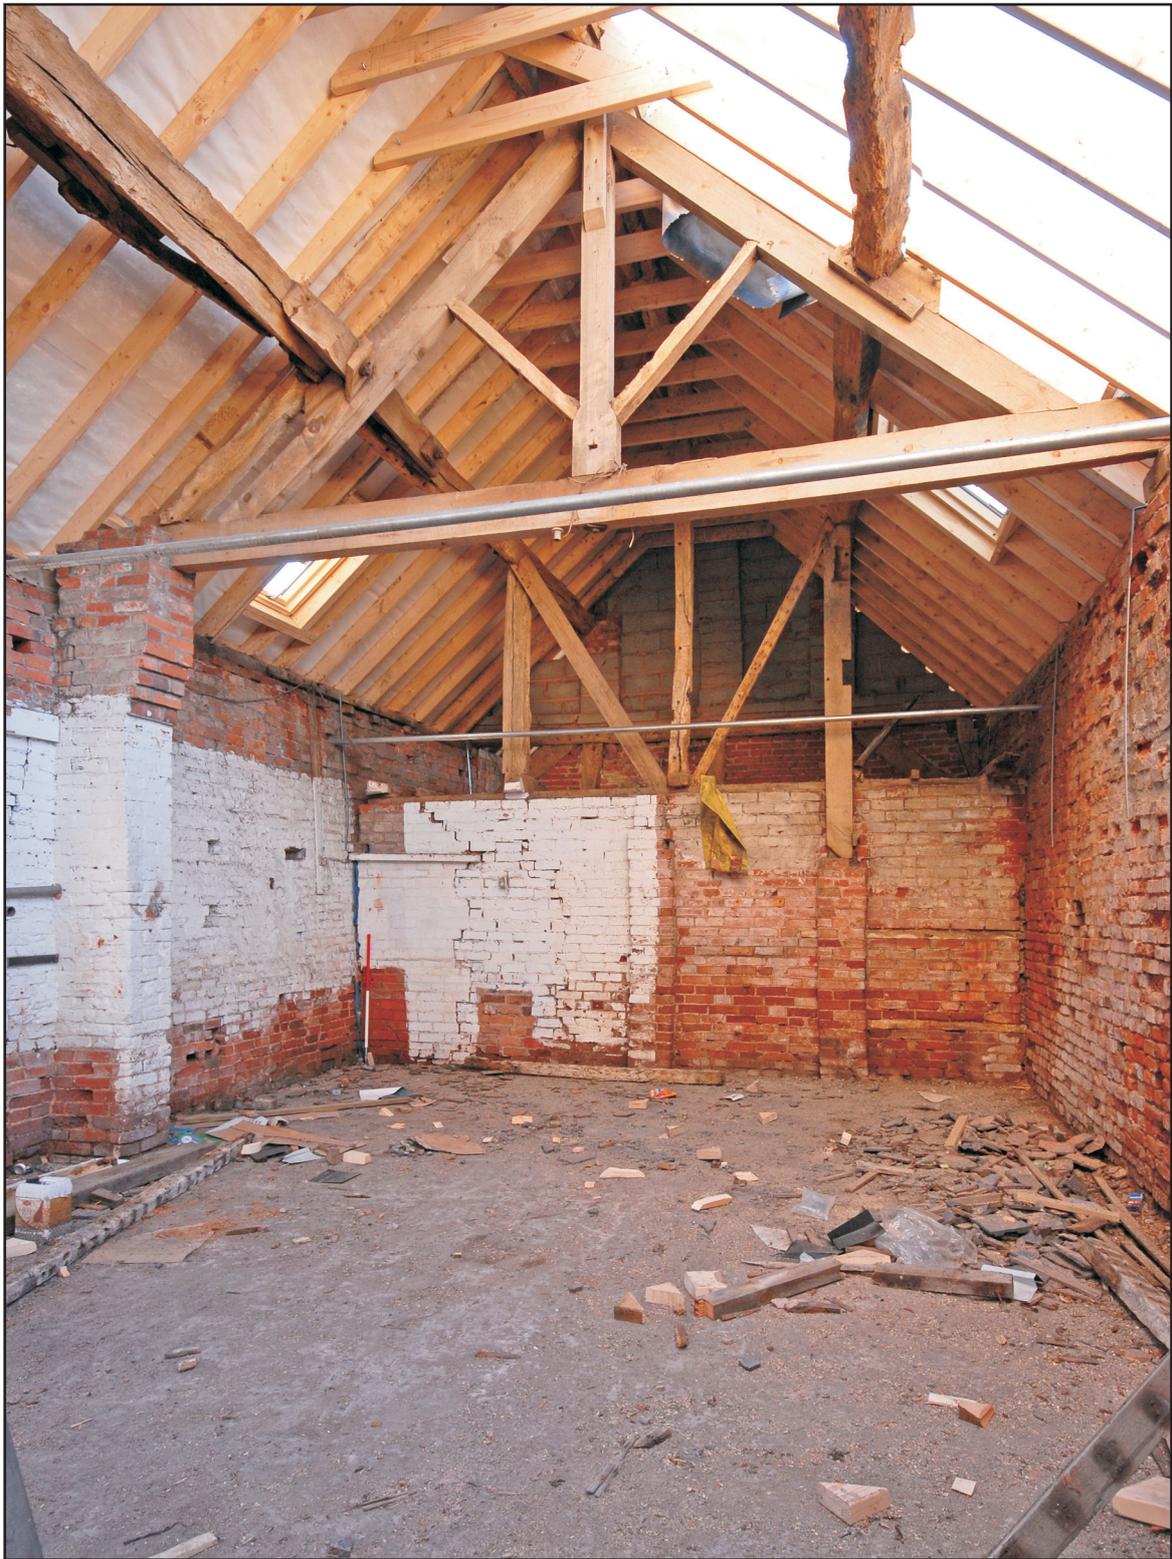
Truss 5 Fig 11

This truss was mid 19th-century machine sawn pine and is likely to have been inserted when an engine was installed which powered the aforementioned drive shaft. This truss was not drawn and no samples were taken for dendrochronological dating. Two samples were taken, however, from the purlins, which both produced dates of 1547.

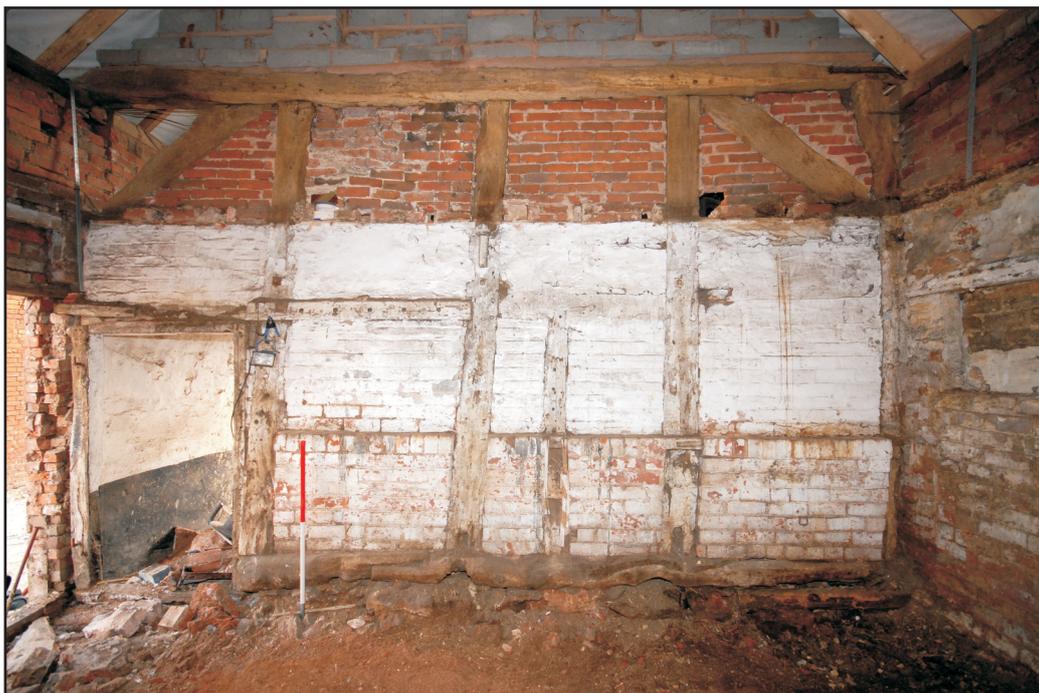
Truss 6, elevation and photograph Fig 12

The gable above the tie beam in Truss 6 had been replaced with modern block-work. Two dendrochronological samples were taken from this truss (14 and 15) but both were undated due to insufficient rings (See Appendix 1). This truss had a greater element of timber framing surviving below the tie beam which formed the end wall between Building 7 and the later extension Building 4 (Fig 12). Here the wall post survived on the western side. Three further vertical timbers were morticed into both

the tie beam and sill beam. Four horizontal mid-rails sections survived, forming box framing. A doorway was set into the eastern side at ground floor level. The remaining panels were nogged with whitewashed brick. The sill beam had an edge-halved scarf joint, to the west of the door. The watching brief during the reduction of the floor level in front of this wall demonstrated that the sill beam sat on red sandstone blocks (Fig 12). There were several empty peg holes in the timberwork of this wall suggesting that several of the timbers had been reused.

A watching brief was undertaken during ground works associated with the re-development of Buildings 4 and 7. The floors which were removed consisted of a 0.04m layer of concrete overlaying mixed crushed brick and concrete 0.1m thick, this overlaid a thin layer of sand over the natural red clay. The thin layer of concrete overlaid a brick floor in the central part of the barn. Although no archaeological features were observed when the floors were removed, (Fig 14), the stripping of modern features from the barn allowed for clearer photography of Truss 6 (Fig 12).

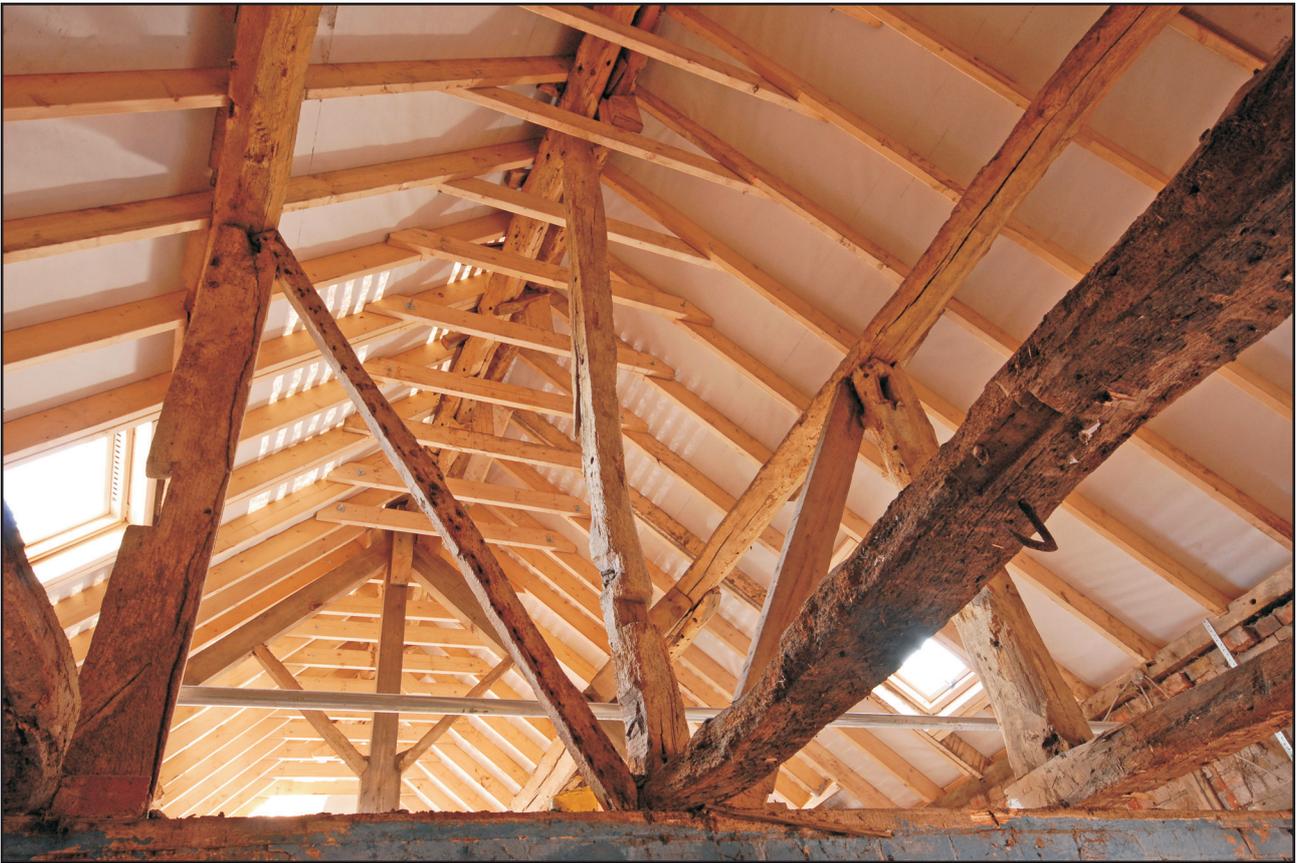
Re-used temporary timber truss Fig 13

Elements of the truss from this wall may have been taken to form a temporary structure to support the purlins when the block-work replaced the truss (Fig 13)

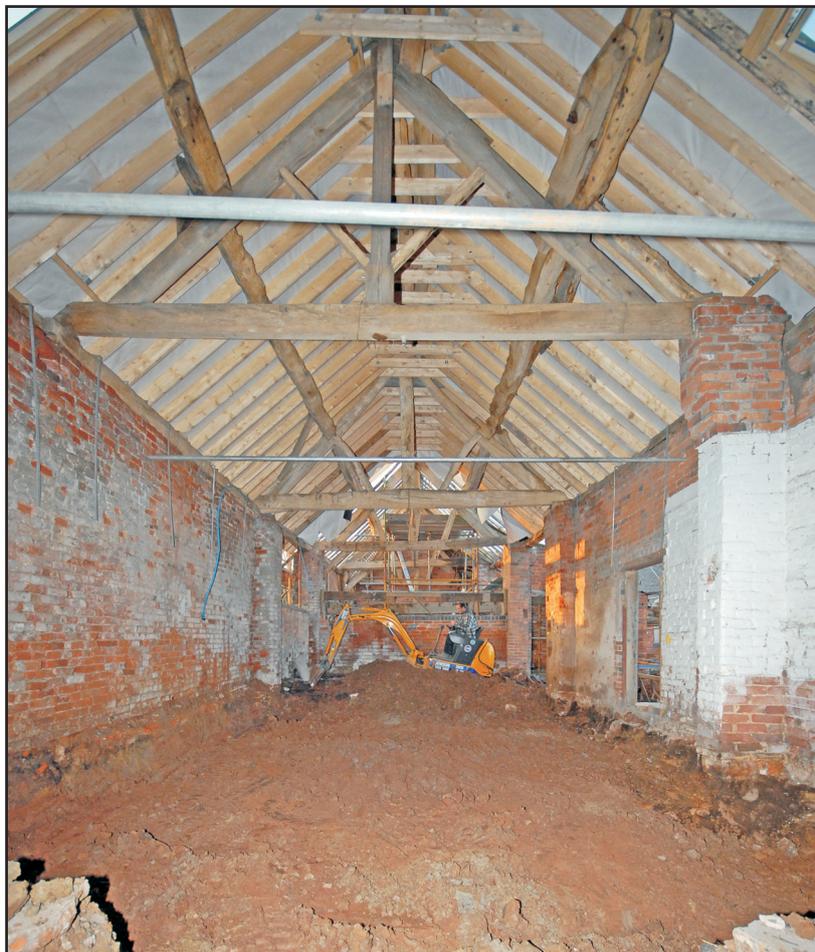
General view of the barn interior during the watching brief, looking north Fig 14

Additional photographs of the interior of the barn were taken in March 2010, following re-covering of the barn roof and the removal of all internal subdivisions.

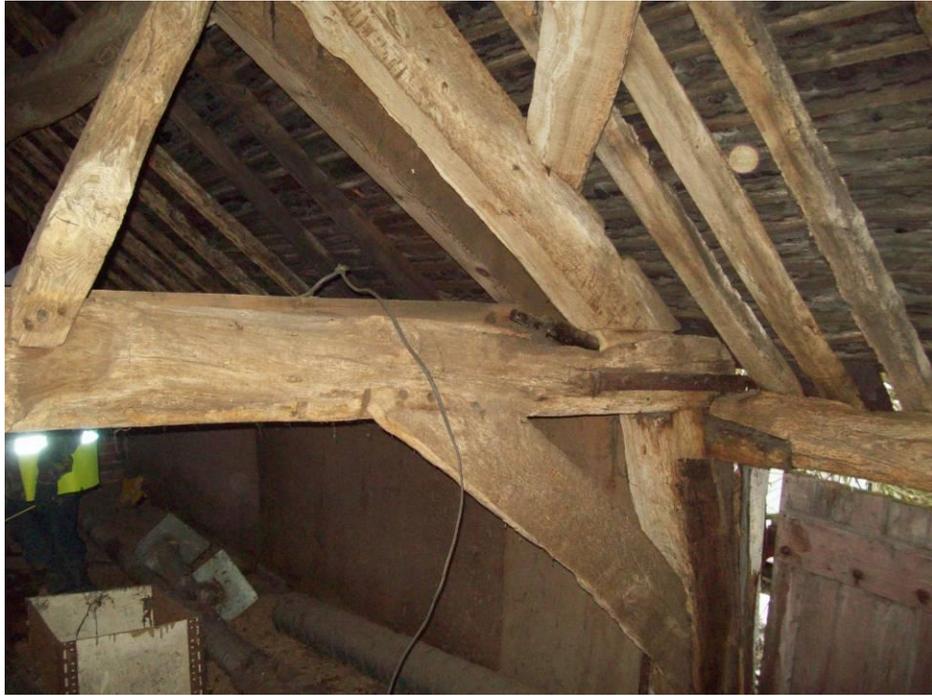
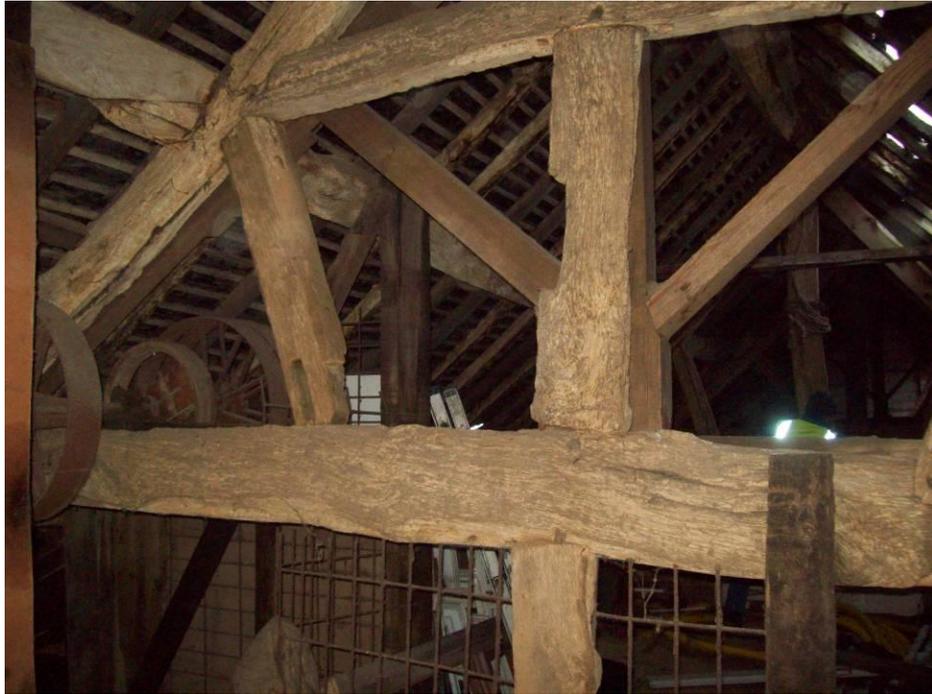
Figure 3a/b: View of the north face of truss showing to show evidence of possible insertion and reuse. Notice in the upper picture the diagonal strut nailed to the tiebeam, and the archbrace from the wall post not fully morticed. In the lower picture an empty mortice can be seen in the strut, and the lower stud post at centre is again not fully morticed into the tiebeam
